## Air Conditioner Opening Maintenance

Bill VanHeulen  
Forsyth Parkside HOA

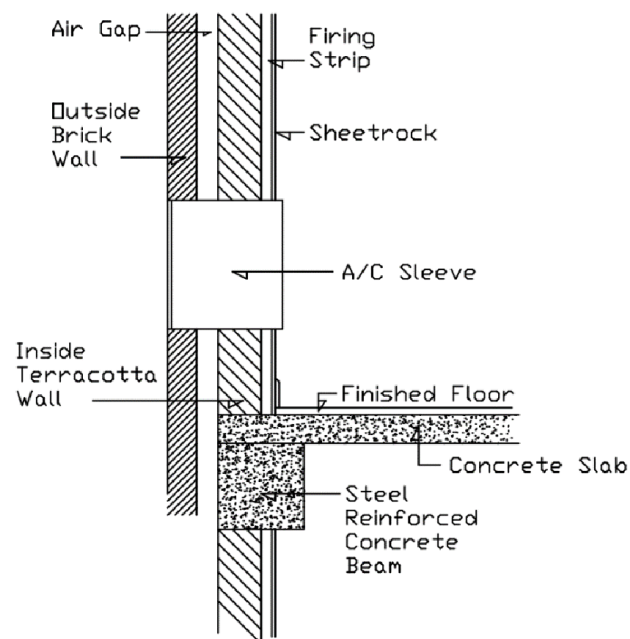
**figure no.5:** The sleeve transitions through the inside terracotta block and the outside brick, and supports the air conditioning unit. When installed properly and maintained, the condensate from the air conditioner will collect in the air conditioner's drip pan, which should have the proper slope to the outside, and drain through a drain line through the outside grate.

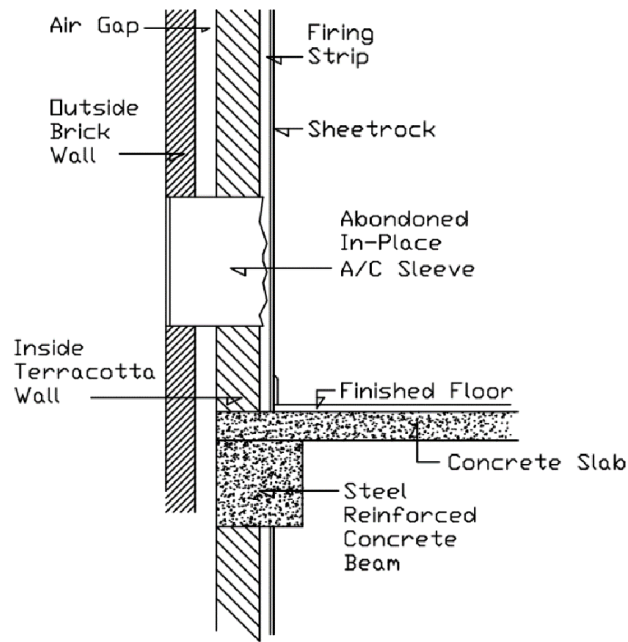
**figure no.6:** We have found that the sleeves from the abandoned-in-place openings have been cut off and left in place...leaving a path for driving rain to get behind the finished walls and travel under the flooring along the concrete floor slab and finding its' way down to units underneath.

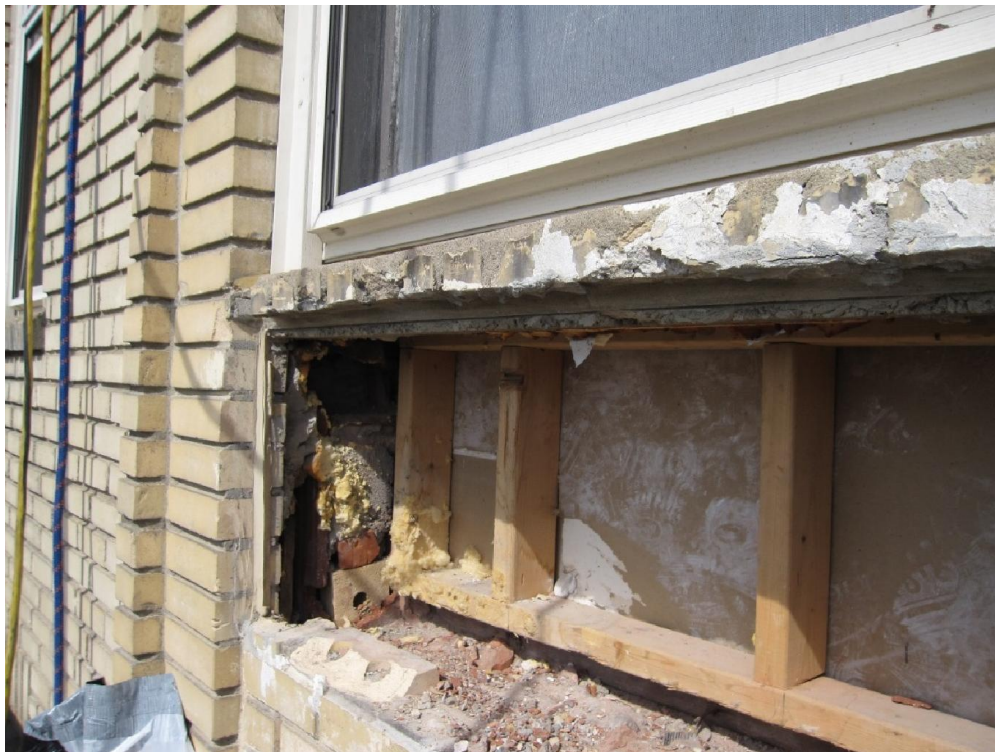
**figure no.7:** This was an A/C opening that was abandoned in place in Unit F5. The picture is after removal of the grate and a foam board that was held in place with expandable foam.

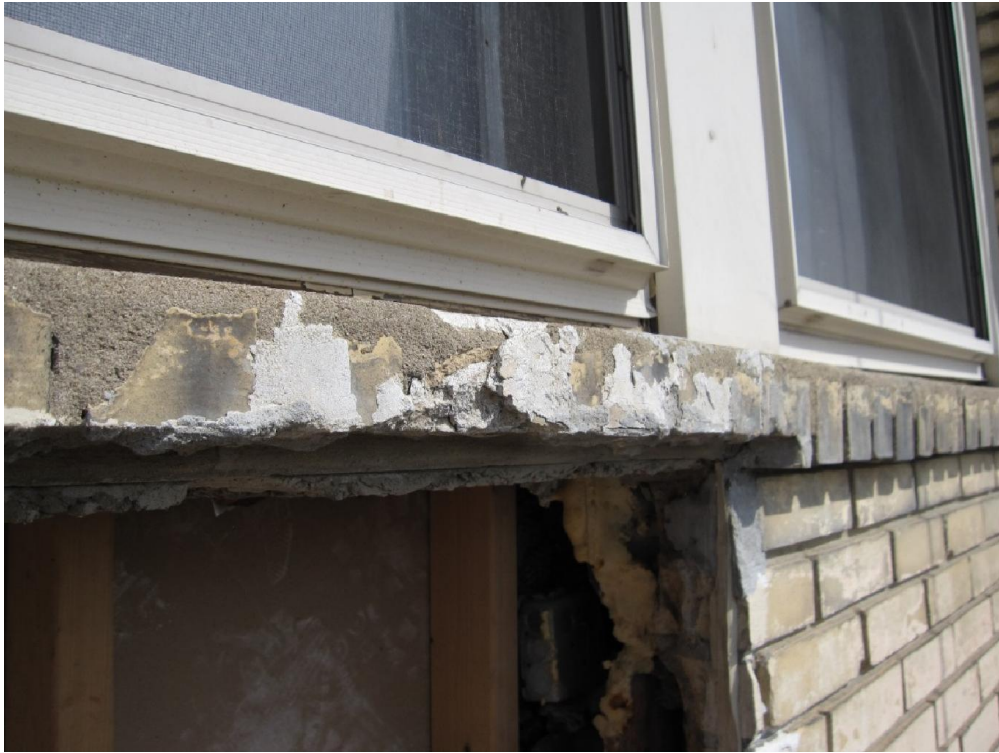
**figure no.8:** This is a picture of a sill cap. It will give you a good idea of the kind a masonry work that has been done by past air conditioning contractors.

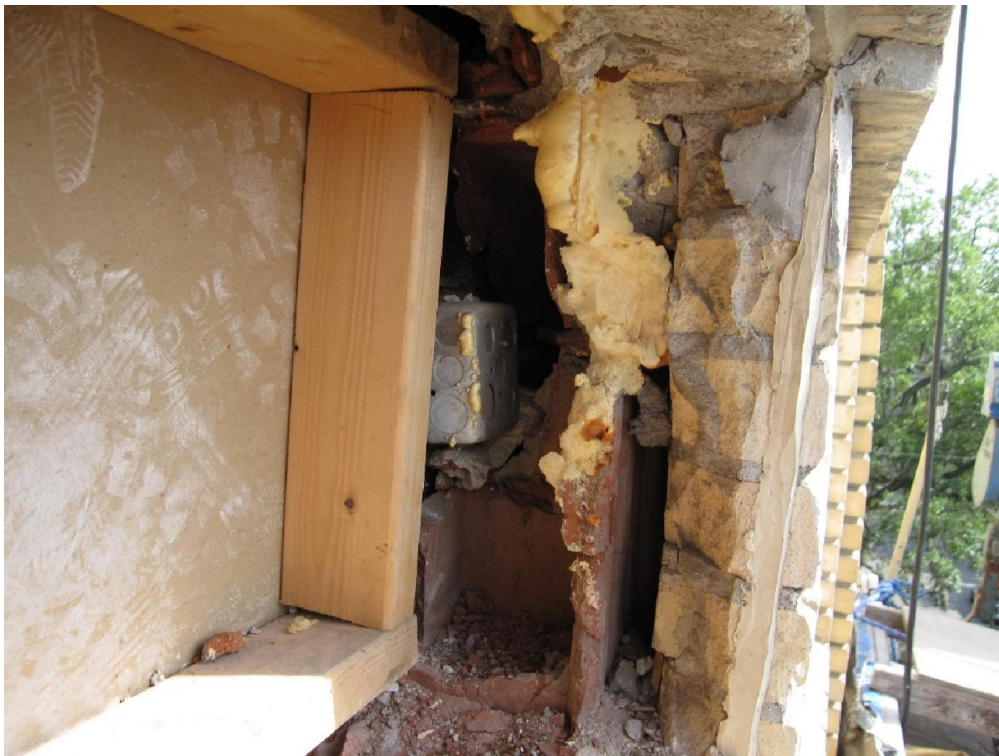
**figure no.9:** You can see that the inside terracotta block was not cut, but broken out to make room for the sleeve. The next step is to clean the debris that was left behind from the previous air conditioning contractor.

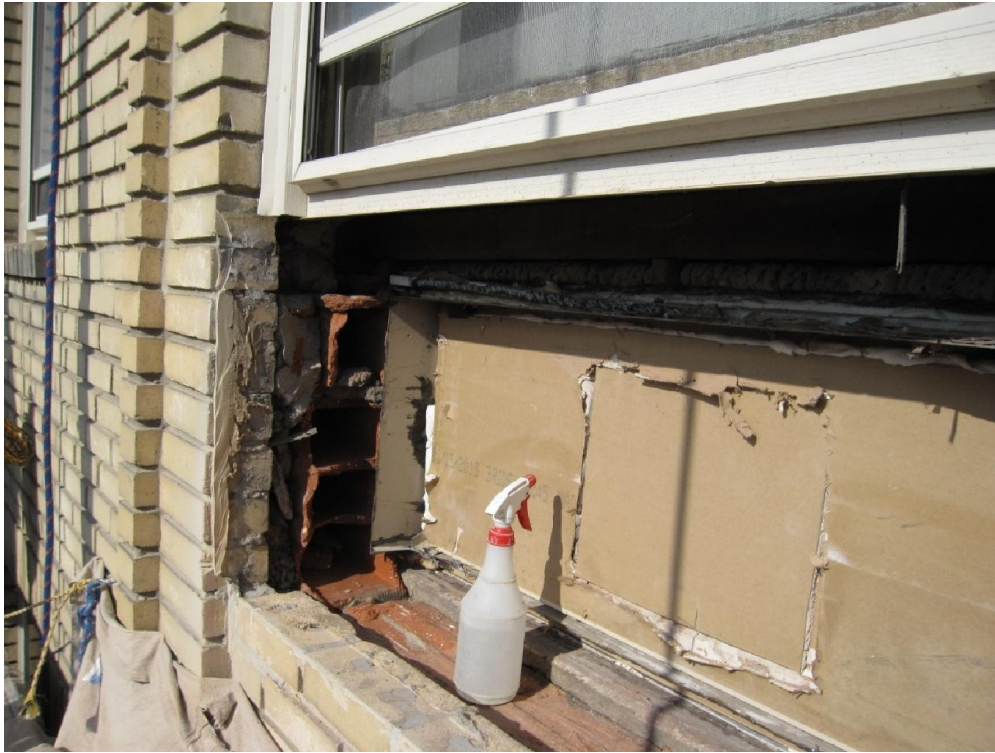
**figure no.10:** This picture is from Unit F4 after the debris has been cleaned up. You can see remnants of the old A/C sleeve that was abandoned in place. Abandoning a sleeve in place provides a path for water infiltration. In a driving rain the water could travel along the sleeve and find its way to the concrete slab, under the floor, and travel until it finds a path to drain. With the old sleeve cut back we now have room to rebuild the inside wall.

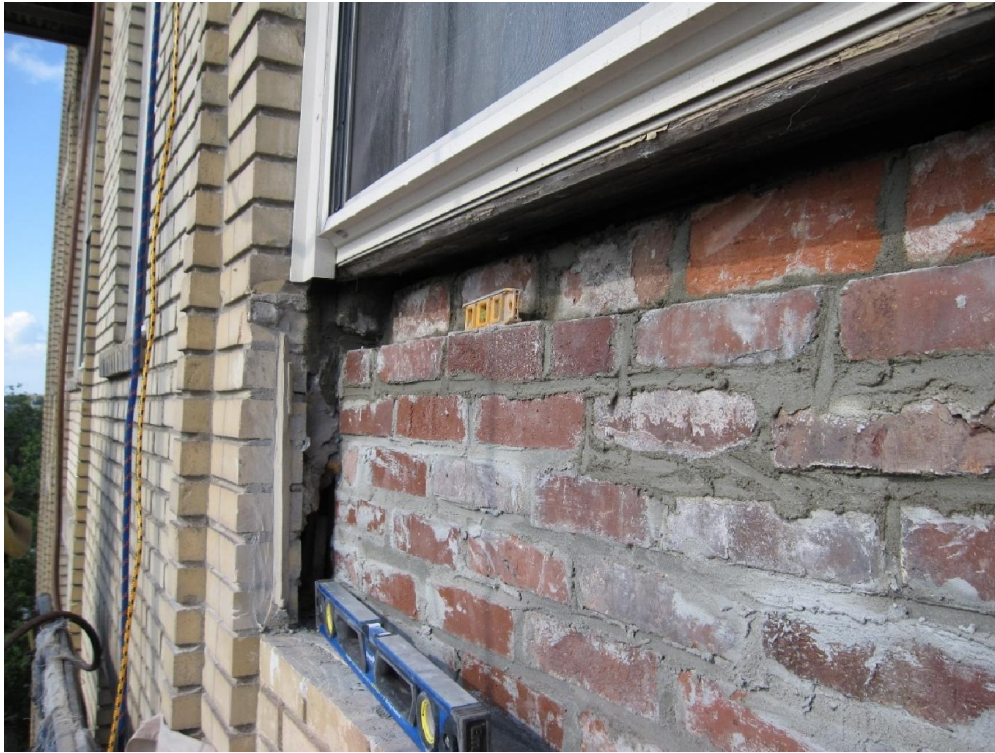
**figure no.12:** A new inside wall is built to replace the missing terracotta section. The new inside wall goes all the way up to support the window. We have found that none the air conditioner openings have lintels installed over the sleeve. A lintel is a steel angle iron that carries the load above.
